Steam Locomotive 3801

Inner Firebox assessment report
Carried out at Maitland, December 15th 2006

Assessed by Puffing Billy Railway Rolling Stock Branch

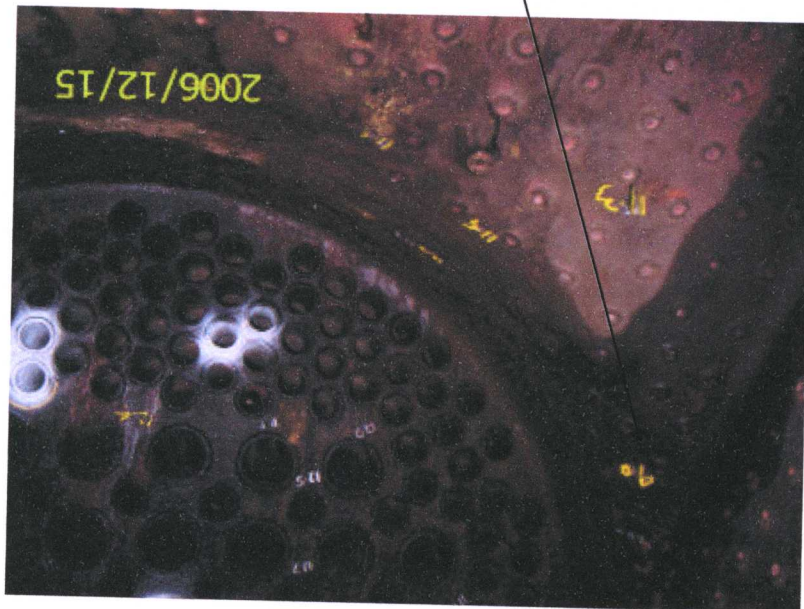
Photo 1. Combustion chamber & tubeplate, LHS

5.2 Some plate thinning was shown during the Ultrasonic testing and this thickness reduction, whilst still acceptable, seems excessive for the amount of steaming that this boiler has had, and points to inadequate water treatment (see later comments re water treatment). Photo 1.

Note thinning at this point

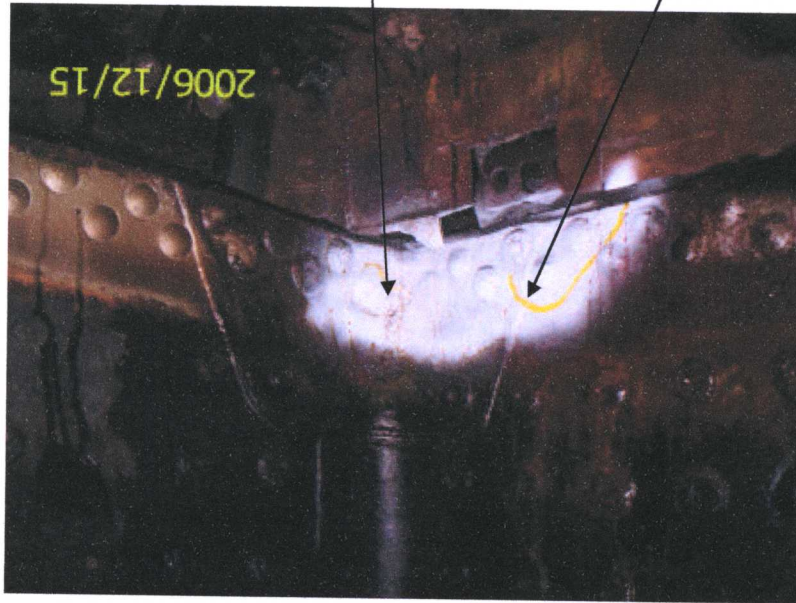
5.4 A plate crack between rivet holes, and leaking rivets in the rear left hand side corner. These were located in a previously fitted corner patch, this patch showing thickness of 12 mm at top but 9mm in crack zone. Photo 4.

Photo 4. LH rear corner of firebox
 Location of crack
 Corner patch

- 3 The cracking in rivet area rear of firebox to be repaired and defective rivets replaced.
 - 4 The Boiler Safety valves to be cleaned tested and any worn or defective parts replaced.

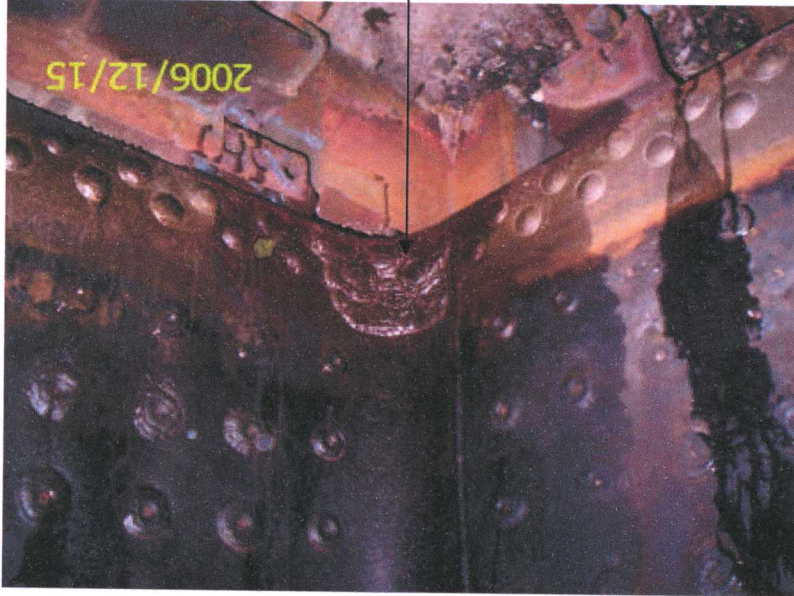
5.5 The right side rear corner has a previously repaired (pad welded) area in a generally similar zone to that of the other corner defects. Photo 5

Photo 5.
 Old weld repair
 Firebox RH rear corner

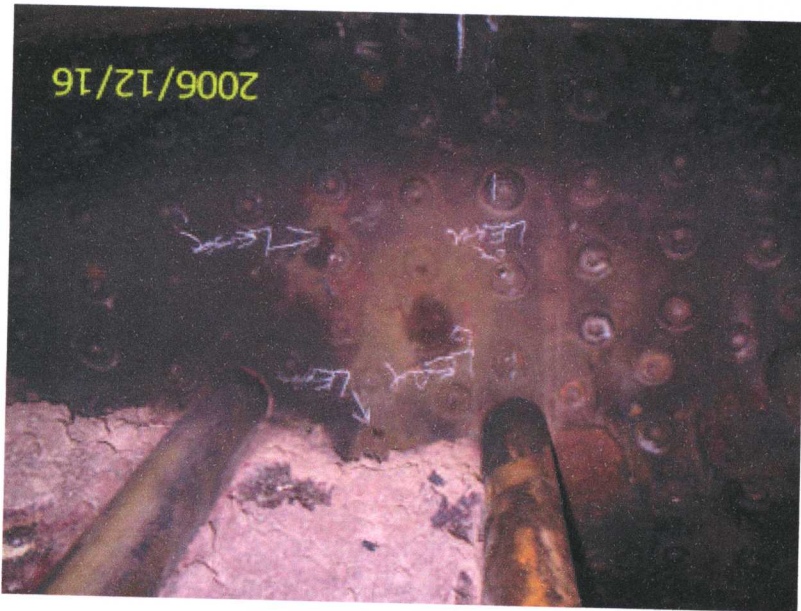
5.6 A number of leaking waterspace stays were noted, together with some thermal cracking and fire wear on stay heads. Photo 6 is typical.

Photo 6. Firebox front plate showing various leaking stays

- Many leaking stay heads were noted on the firebox end. Over the years, quite a number have been seal welded as leaks developed. The Victorian Railways introduced the practice of seal welding of the firebox end of all waterspace stays at installation, for boilers built during the post WW2 era. It is recommended this method be used on 3801.
- As stated earlier, (par 2 Limitations...), the life expectancy of this boiler can only be properly estimated after much more extensive investigations, involving significant dismantling, NDE, and prolonged down-time for the locomotive.

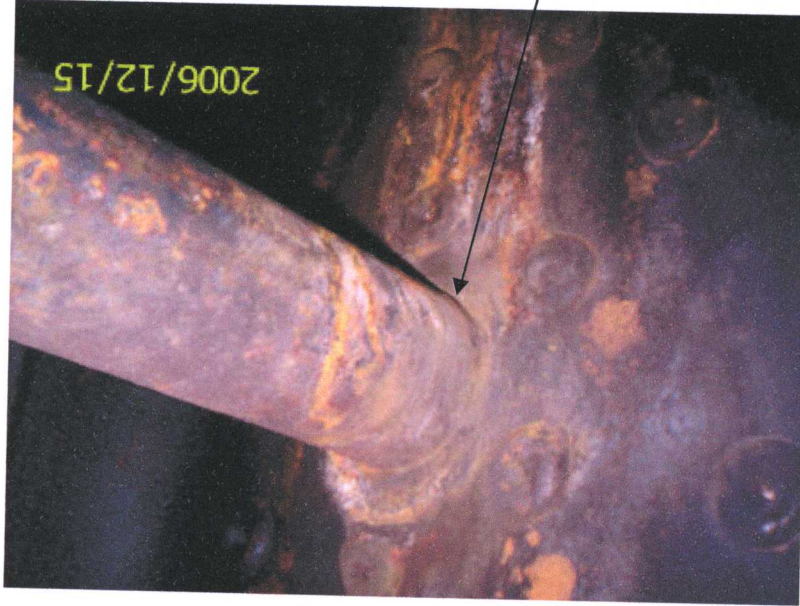
5.7 One stay broken (leaking from tell-tale hole) on front sheet RH side. 5.8 The LH arch tube leaking at the expansion into the door plate. Photo 7.

Photo 7. Leaking arch tube expansion (LH tube rear end)

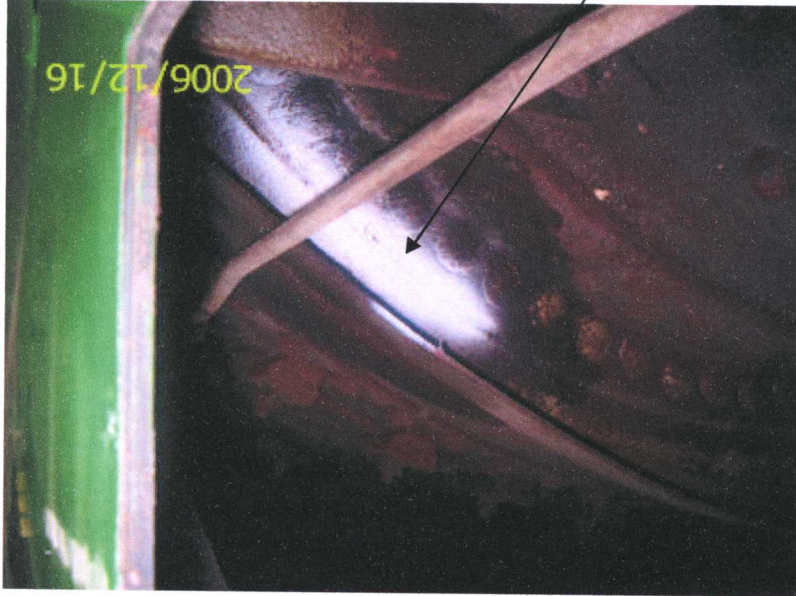
Photo 9 Barrel angle ring/ smokebox tubeplate RHS
Location of leak on caulking

5.11 Leak on caulk line between the smokebox tubeplate and barrel angle ring, RH side between rivets Nos 7 to 9 counted from top centreline of barrel. Photo 9.
Other defects noted:-

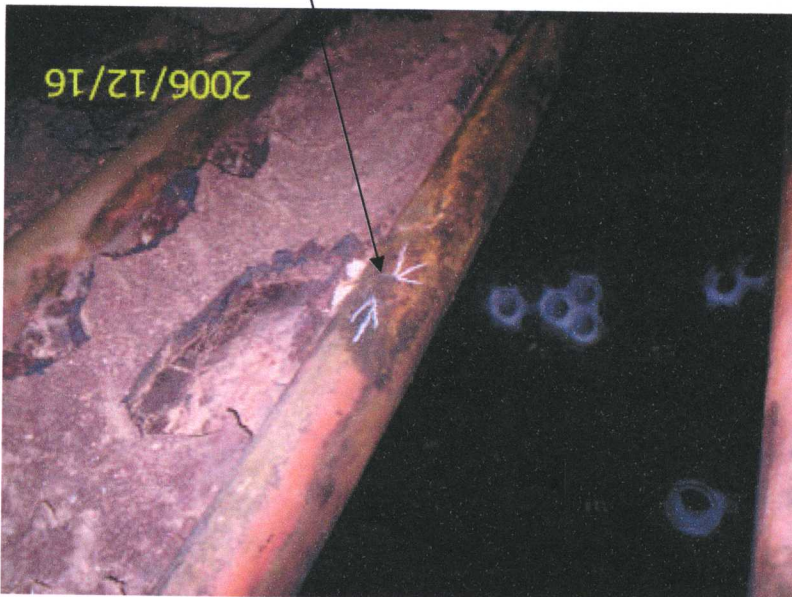
5.9 The centre arch tube pin hole leak on tube bottom about 700mm from throat plate end. Photo 8.

Photo 8. Centre arch tube, location of pin hole leak

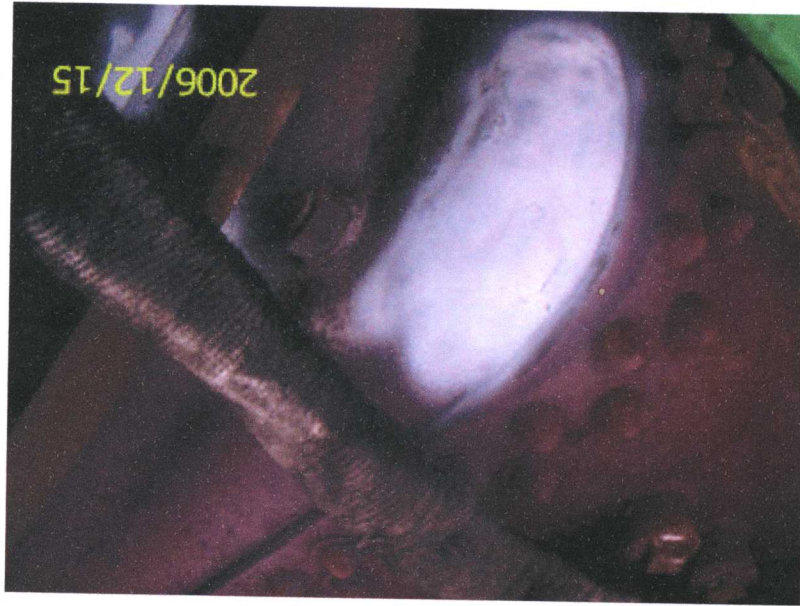
Photo 10. Top of Belpaire ring and firebox wrapper

5.12 Corrosion of plate at LH blowdown valve seating.
5.13 A couple of locations on the joint between the Belpaire ring and firebox outer wrapper were suspected of having leaked at some time, but no leaks showed under hydrostatic testing, although this was only carried out at mains pressure of approximately 80 psig at Maitland. Photos 10 and 11 show the locations in question.

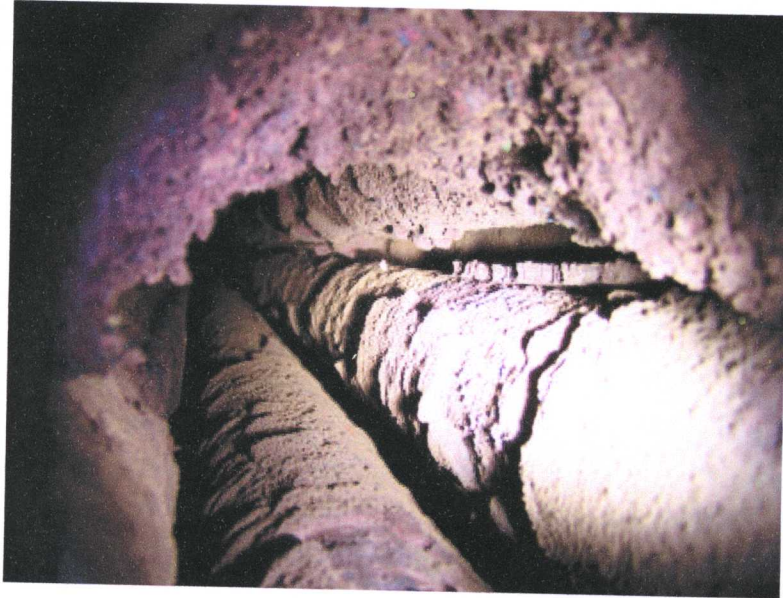
Heavy scale on boiler tubes

Photo 12. Picture taken at Thirlmere by RTM boiler inspector viewed through flue hole whilst flue renewal in progress Jan 2007

photographs taken at Thirlmere recently (photo 10) during flue replacement on 3801, which show a boiler absolutely covered with heavy scale. Such scale causes a rise in the metal temperature of any plate or tube exposed to combustion, due to its insulating effect, and such temperature rise is the main cause of thermal fatigue (cracking) failures of tubes, flues, stay heads, and inner firebox plates, and is the main contributing cause of water space stay failure.

The internal condition of this boiler, as demonstrated by the photograph (photo 10) mentioned, may well make it a candidate for a full internal chemical de-scaling treatment. Such a treatment was used, apparently successfully, some years ago by the Pitchi Ritchi Railway in South Australia, and is the subject of an article in 'Australian Welding', the journal of the Welding Technology Institute of Australia (WTA), Vol 42, 4th quarter, 1997, pp 16, 17, 28, entitled "Maintenance and restoration of Steam Locomotives".

- It is imperative that the water treatment be improved, and also that the boiler should be de-scaled as soon as possible, to allow such water treatment to work. Continued operation in the current condition of heavy scaling will cause ongoing damage and deterioration, thus forcing the need for heavy maintenance and causing a drastically curtailed service life.

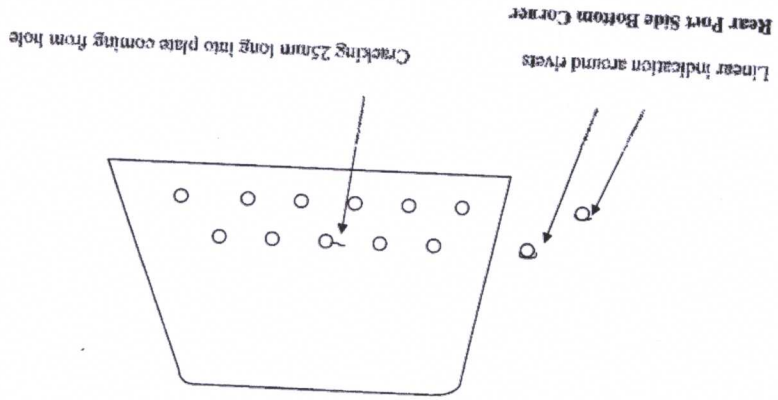
5 off tubes in rear tubeshet welds revealed crack-like indications (Refer attached sketch)
Rear port side bottom corner of firebox revealed cracking extending from rivet
Rear port side bottom corner revealed linear indications around two rivets
All indications as marked and referred to client representative.
