Mr. Ray McBrien (Engineer of Standards and Research, Denver & Rio Grande Western Railroad): Gentlemen: Mr. Harper asked that I give you a short paper covering current information which we have acquired in connection with our research studies of steel for firebox boilers.

In spite of the interest that has been manifested failures continue to occur and on our own road we are trying to correlate the study of service failures with research. For example our unfortunate explosion of passenger locomotive 1804 brought out very forcibly the added factor of safety which temperatures are available by the use of materials with higher strength at elevated temperatures.

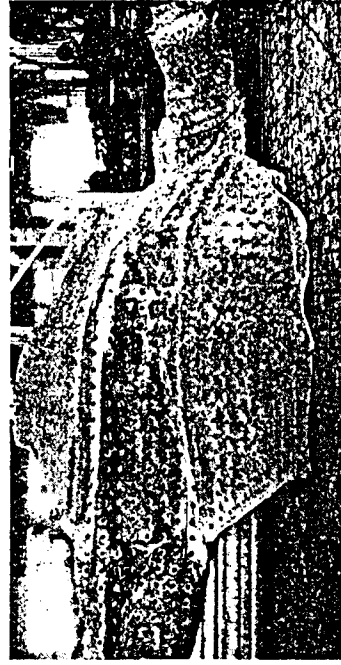
Slide 1

A novel feature of this investigation was the use of color photography. I have had prepared some color photographs from the original which I would like to show. Slide (1) is portions of the crown sheet, door, and sides of firebox syphons. It will be noted that the syphons sides display a normal steely color; the crown sheet and portion of the door show the discoloration from overheating. The origin of the failure was at a point adjacent to combustion chamber syphon and the highest point of the crown sheet.

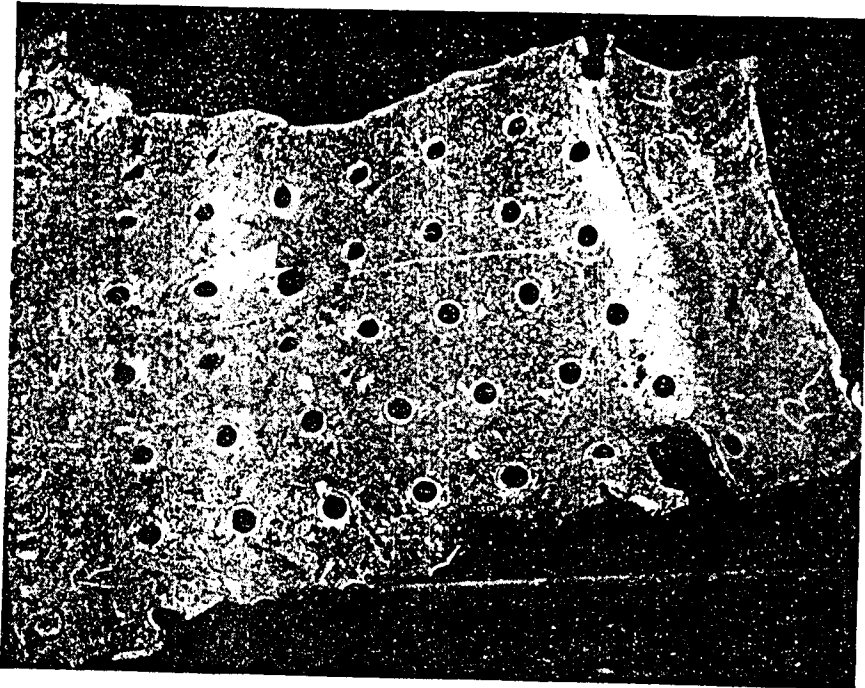
Slide 5

*Slide (5)*—Is a picture of the section of the door sheet missing from the portion shown in slide (4).

These color photographs show obviously that the primary cause of this explosion was due to overheating from low water. Metallurgical examination and study indicates that by the use of a material with greater strength at elevated temperatures this failure might have been prevented.

The microstructures found at various locations around the firebox showed that maximum temperature was reached at a point coincident with the origin of the explosion and established the maximum temperature as between 1350° and 1400° F.

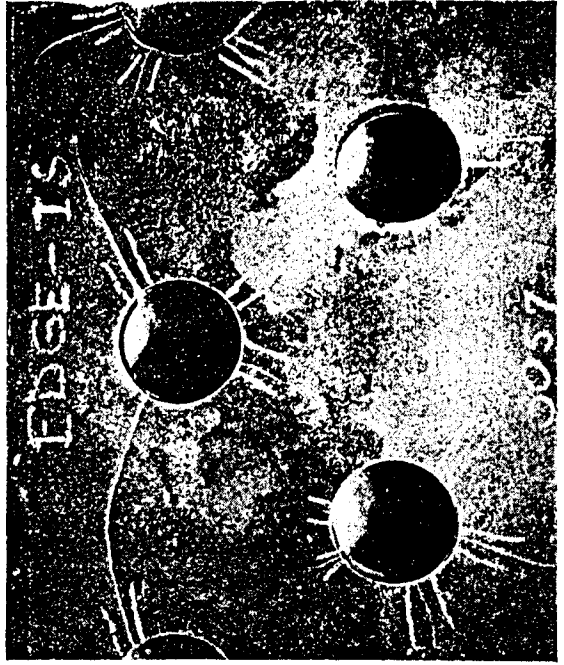
Slide 11

The importance of fabrication practices is further demonstrated as shown by the failure illustrated in the next Slide (11) which shows cracks in a section of a boiler shell seam. These cracks are outlined with magna-flux powder and indicated by white lines. The micrographs showed these cracks to be transcrystalline, and this brings out the important point of properly identifying failures.

It was found that these cracks originated at the sharp edges of the holes. Some had referred to them as embrittlement cracks; the micrographs show they were transcrystalline. This brings out the need for recognizing the necessity for removing all sharp edges from riveted seams, as sharp knife edges only result in localized stress concentration and possible failure.

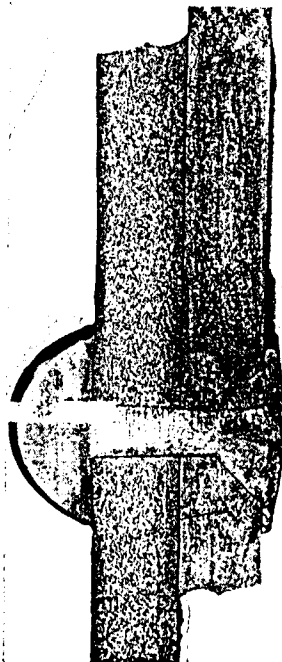
Slide 12

The next Slide (12) is a etched cross section of a riveted seam showing the sharp corners in the rivet hole and the deformation of the plate from high caulking pressure. This practice helps to provide the conditions necessary to get failures from stress concentrations which can develop intergranularly or transcrystalline.

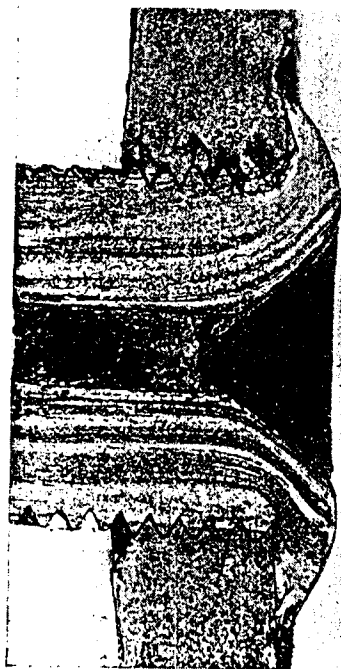
Slide 13

The next Slide (13) is of a section of firebox side sheet and staybolt, showing a crack originating in the interior of the sheet at the root of a thread where the stress is concentrated at a sharp corner. This etched section again demonstrates the need for understanding the elevated temperature properties of both the side sheet and staybolt materials. The side sheet was corrugated, indicating lack of the necessary strength under load under operating pressure and temperature.

The effect of corrugation is to cause the threads to engage mostly on the fire side of the sheet. In consequence of such action the staybolt bears all its load at the last few threads. Since the end of the bolt is at a relatively higher temperature, the net effect especially with the ordinary iron or steel bolts, is that the bolt is much weaker than calculated and its sustaining unit load is much greater, due to its loss of strength from temperature effects. We have found that by the use of such an alloying element as molybdenum we can secure an iron or steel alloy with the increased strength at elevated temperatures.

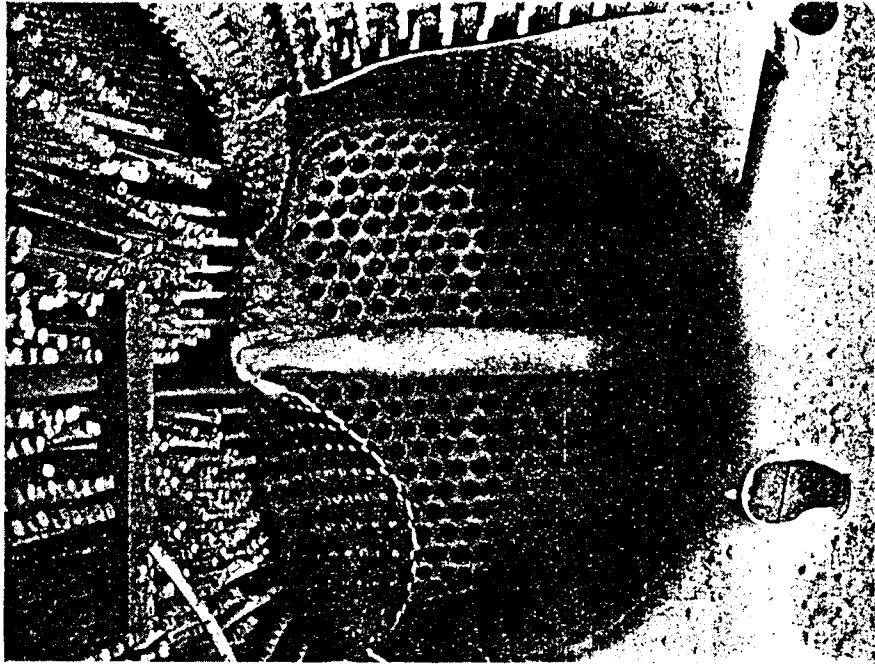
Slide 3

Slide (3)—Is a photograph taken inside the firebox of the combustion chamber syphon, the back flue sheet, and the same portion of crown sheet shown in slide (2). The discoloration is shown down to the 8th row of flues showing the extreme low water condition at the time of the explosion. From the color line in the firebox and from the boiler dimension it has been calculated that at the time of the explosion the water level was at least 2,750 gallons below the bottom of the gauge glass. Of passing interest it will be noted that the combustion chamber syphon adds considerable structural stiffness to the crown sheet as shown in the manner in which the crown sheet sagged on both sides of the syphon.
